1967 and 1968 CORVETTE TELESCOPING STEERING COLUMN DISASSEMBLY & REPAIR INSTRUCTIONS - PAPER #1

Disassembly and Repair Instructions Addressed in this Paper

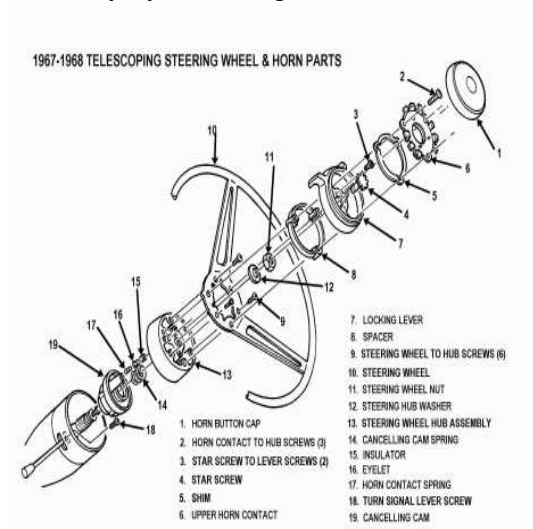
Carefully reach under the horn button cap assembly #1 with a small screwdriver and pry the cap from the horn contact #6. 1967-68 cap assemblies consist of three pieces that are all staked together. At this time, you might want to check the underside of the cap assembly to make sure that the three stakes are secure. You may even want to add some JB Weld to the stakes for insurance.

Remove three screws #2 securing horn contact #6, shim #5, and spacer #8 to steering wheel hub assembly #13. Remove two small screws #3 and remove star screw #4 and locking lever #7. If needed the steering wheel #10 can now be detached from the hub assembly by removing six screws #9,

Remove the steering wheel nut #11 and the hub washer #12. You should be able to see a small indentation on the steering wheel hub assembly and a similar indentation on the very end of the steering column shaft. The two marks should be aligned.

Next, using a steering wheel puller, remove the steering wheel #10 and hub assembly. Make sure that your puller and bolts are square to the hub as you turn the large bolt and apply force. I also place a heavy washer on the end of the steering shaft so that the large puller bolt does not distort the threads on the end of the shaft. Never hammer on the end of the steering shaft.

You can now remove the large spring #14 and the canceling cam #19. There should be a spring loaded plunger (called eyelet #16) that protrudes from the tower on the canceling cam. You should be able to freely depress the eyelet against the small spring #17 inside the tower. Insulator #15 holds them in place. It can now be removed to access the eyelet and spring if these parts are to be inspected or replaced.

Note: From this point onward please refer to the steering wheel drawing on page 2.

Assemble plastic covers and escutcheon (1967) or covers and closeout panel (1968). Place the canceling cam #19, the large spring #14, and the steering wheel hub assembly #13 on the steering shaft. The horn tower on the canceling cam (with the eyelet, spring, and retainer) fits through the hole in the hub. Align the mark on the hub to the mark on the end of the steering shaft. Assemble washer #12 and steering hub nut #11. Torque nut to 35 ft-lbs.

Attach the steering wheel to the hub with six screws #3. It is suggested that you loctite these screws since they have a tendency to loosen. Torque to 20 inch-lbs. The 6 o'clock spoke on the steering wheel should be opposite the mark on the end of the steering shaft.

Place the spacer #8 on the steering wheel hub assembly. Set the telescope locking lever #7 on top of the spacer (with the steering wheel straight ahead, the finger tab part of the lever should be in the 12 o'clock quadrant). Thread the special "star" screw #4 into the end of the steering shaft. Now, use a phillips screwdriver to tighten the "star" screw until you can no longer telescope the steering shaft. Place the finger part of the locking lever at about the 1 o'clock position. Secure the locking lever to the "star" screw in that position with the two small screws #3. Torque them to 30 inch-lbs. You can now test the effort required to lock and unlock the telescope feature. Readjust the locking lever to suit your preference.

Place the shim(s) #5 and the upper horn contact #6 on the spacer. Attach the horn contact to the hub with three screws #2. Torque to 19 inch-lbs. Make sure that the eyelet plunger #16 sticking up through the hub touches the horn contact. Snap on the horn cap #1.

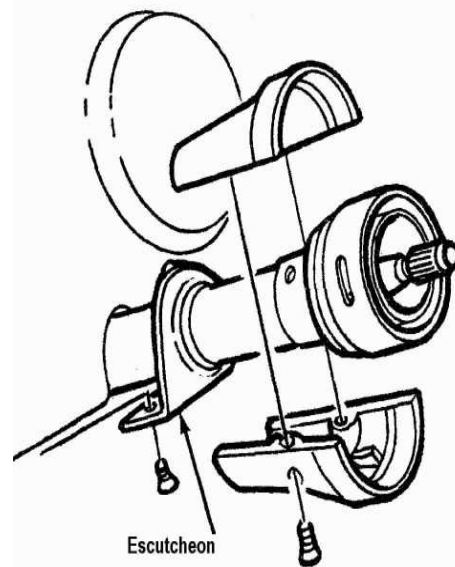
1967 CORVETTE STEERING COLUMN COVERS

Go down under the dash and disconnect the curved turn signal switch connector from the vehicle body harness. The 1967 steering column has a part called an escutcheon #7 installed on the steering column jacket. It serves to close the gap between the instrument cluster and the steering column. Detach the two plastic covers from the column head by removing two screws. Remove the two screws that attach the escutcheon to the dash.

You will now have access to remove the metal turn signal switch wiring protector #1 by removing the two screws #2 and unsnapping it from the jacket. The turn signal switch wires pass through a narrow gap between the escutcheon and the column jacket.

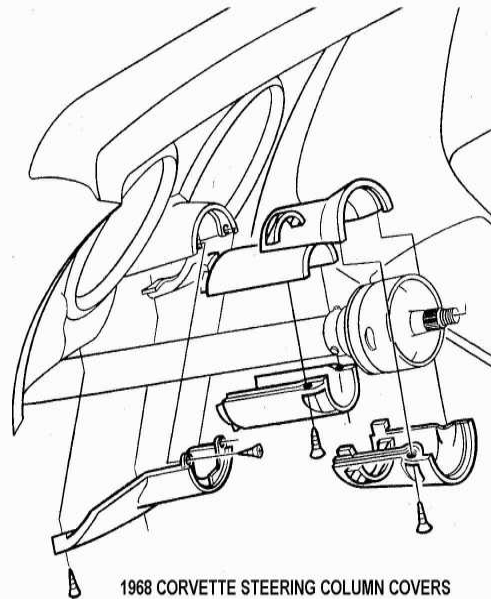
Go down under the dash and disconnect the curved turn signal switch connector from the body harness. In order to gain access to metal trough #1 that protects the wiring you will need to remove the covers and closeout panel that surrounds the steering column. Remove the fasteners and the four plastic covers that enclose the upper end of the steering column. Remove the four fasteners and the closeout panel that is underneath the column.

Remove the two screws #2 on the sides of the steering column jacket that hold the metal turn signal wiring protector #1 in place. Unsnap the protector from the mast jacket. The wires are now free to pass up and through the bearing housing #5 and the signal switch cover #6.

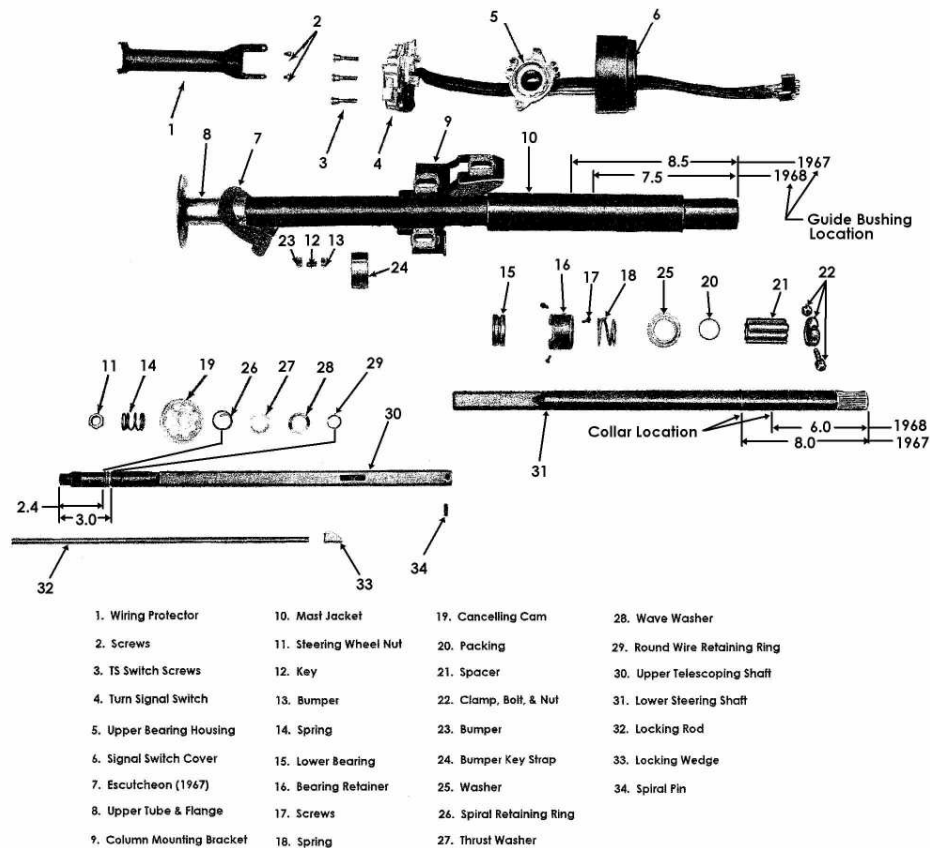
1967 (Late) Corvette Telescoping Steering Column Blowup

1968 Telescoping Steering Column Similar

I have compared the telescoping steering column blowup pictures in the 1967 & 1968 Chevrolet Chassis Repair Manuals versus the steering column engineering drawings for those years. For the most part, neither of the manuals reflect the engineering drawings accurately. I have updated the blowup drawing in the following areas:

- 1). There is a round wire retaining ring #29 on the upper telescoping shaft #30 that is not called out in the original blowups. It is installed in a groove that is located 3.0 inches from the steering wheel end of the shaft. That ring is GM #5694191 and is available through GM dealers, numerous Corvette suppliers, or at salvage yards.

- 2). There is also a spiral pin #34 that is pressed into the other end of that shaft. It prevents the telescoping shaft from pulling out from the lower shaft #31.

- 3). The lower bearing package shown in the 1967 manual is completely wrong. Parts shown in the 1968 manual are misidentified. Lower bearing parts (#15, 16, 17, 18, 20, 21, 22, & 25) shown in my blowup now match the engineering drawings.

- 4). There is a small collar that is permanently assembled on the lower steering shaft that seats the lower bearing. It is not serviceable but its location differs from 1967 to 1968.

- 5). There is a plastic steering shaft guide bushing inside the steering column mast jacket #10. It should not need servicing. Its location differs from 1967 to 1968.

Note: All component part numbers on the next several pages refer to parts that are shown on the Steering Column Blowup at the end of this paper.

Assemble the upper bearing housing #5 and turn signal switch #4 into the cover #6. On the 1967 column pass the turn signal switch wires through the escutcheon #7. Assemble the parts over steering shaft #20. Secure parts to the upper tube and flange #8 with three screws #3 tighten to 30 inch-lbs.

Slide wave washer #28, thrust washer #27, and spiral retaining ring #26 onto steering shaft. Press parts together and seat retaining ring into groove in steering shaft. Make sure that the retaining ring is fully seated.
