1969 THROUGH 1976 GM A & F-CAR TILT STEERING COLUMN DISASSEMBLY & REPAIR INSTRUCTIONS PAPER #3

Disassembly and Repair Instructions Addressed in this Paper

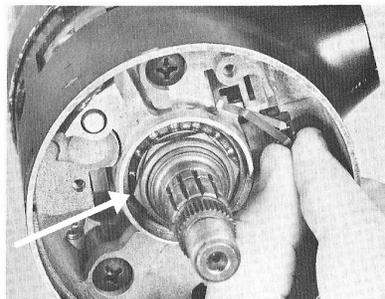
Remove upper bearing lock nut. Use a long thin wall socket. Push upper steering shaft into the jacket sufficiently to remove upper steering shaft inner race seat and inner race. Later tilt columns did not use a nut, the inner race was preloaded by a spring.

EARLY (1969-70) 2ND GENERATION ENERGY
ABSORBING TILT COLUMN WITH UPPER BEARING
PRELOAD NUT

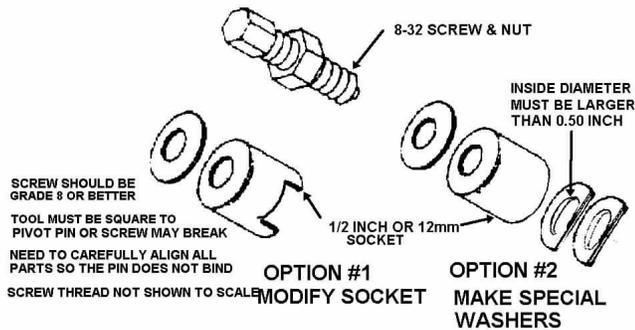
Remove the two pivot pins #30. Each of the pins has a tapped hole so that you can use the GM tool or jury rig a puller using an 8-32 screw, nut, washer, and a 1/2 inch or a 12mm socket. Bridge each pin with the socket and use the screw and nut to pull them out. You will note that the bowl of #53 Gearshift Lever Housing comes right up to the edge of each pivot pin. You cannot react against the fragile bowl. But you also must keep your removal tool square to the pivot pins. Two home made tools that provide clearance to the bowl and keep things square are shown below. Some people have successfully threaded a screw into the pins and pried them out with a pair of pliers.

TILT OR T&T STEERING COLUMN PIVOT PIN PULLER TOOLS

One other method to extract the pivot pins would be to thread a 8-32 screw into the end of each pin. Grip the screw with a slam puller tool. A few quick raps should draw the pin right out.

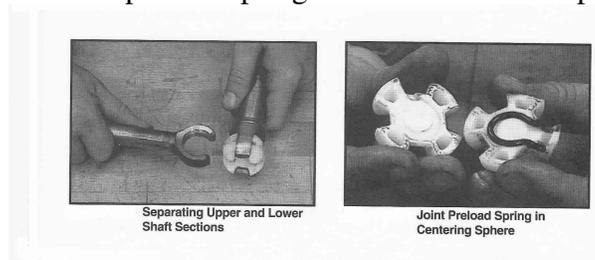
Separate the upper from the lower shaft by bending the upper shaft at a 90 degree angle to the lower shaft. You will now be able to pull them apart. The plastic sphere will remain in the yoke of the upper shaft. Rotate the sphere 90 degrees and it will slip out of the yoke. Note that there is a preload spring in between the two spheres.

Now take a mallet and tap on the lower shaft yoke ears. Do not tap on them too hard! Reassemble and try the “slump test” again. Continue tapping on the yoke ears until the looseness in the ball joint is eliminated.

You can reassemble the shafts by first installing the spring in between the two spheres. Slide and rotate the spheres into the upper yoke. Position the lower shaft onto the upper yoke and rotate the lower shaft 90 degrees, making sure that the upper shaft and the lower shaft are oriented correctly.

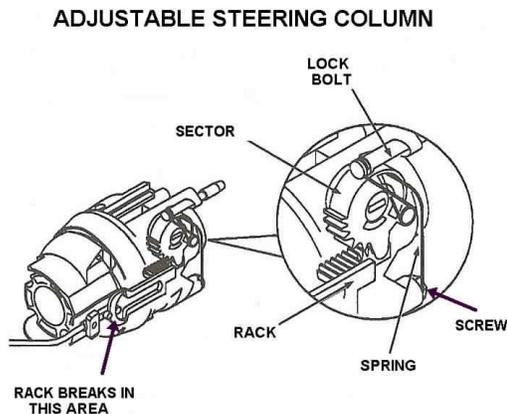
Install the lock bolt and engage with the sector. Install the rack and leaf spring. (Replace shim if one was removed.) The big space on the rack must engage the big tooth on the sector.

Install the drive shaft into the housing. Lightly tap the sector onto the shaft far enough to expose the snap ring groove. Replace the snap ring if it was removed. On later columns, lightly tap the sector onto shaft far enough to snap sector into drive shaft groove.

Install the bolt spring and spring retaining screw. Tighten screw to 35 inch lbs. Install the ignition switch actuator rod through the shroud from top and insert in the slot in the support

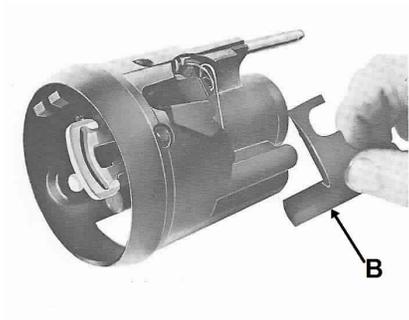
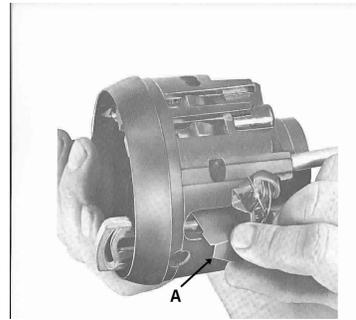
The 1969-76 tilt column has two shields. There is a tilt lever shield A and a turn signal lever shield B. The following pictures describe the installation of the two shields that are used in a 69-76 tilt column.
