1967 (Late) and 1968 CORVETTE TELESCOPING STEERING COLUMN DISASSEMBLY & REPAIR INSTRUCTIONS - PAPER #1

Disassembly and Repair Instructions Addressed in this Paper

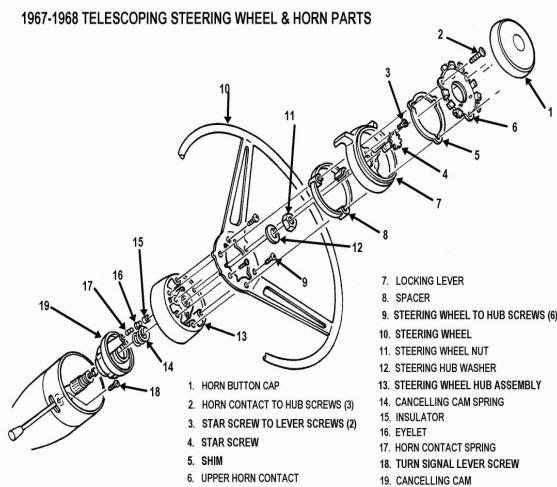
Carefully reach under the horn button cap assembly (1) with a small screwdriver and pry the cap from the horn contact (6). 1967-68 cap assemblies consist of three pieces that are all staked together. At this time, you might want to check the underside of the cap assembly to make sure that the three stakes are secure. You may even want to add some JB Weld to the stakes for insurance.

Remove three screws (2) securing horn contact (6), shim (5), and spacer (8) to steering wheel hub assembly (13). Remove two small screws (3) and remove star screw (4) and locking lever (7). If needed the steering wheel (10) can now be detached from the hub assembly by removing six screws (9).

Remove the steering wheel nut (11) and the hub washer (12). You should be able to see a small indentation on the steering wheel hub assembly and a similar indentation on the very end of the steering column shaft. The two marks should be aligned.

Next, using a steering wheel puller, remove the steering wheel (10) and hub assembly. Make sure that your puller and bolts are square to the hub as you turn the large bolt and apply force. I also place a heavy washer on the end of the steering shaft so that the large puller bolt does not distort the threads on the end of the shaft. Never hammer on the end of the steering shaft.

You can now remove the large spring (14) and the canceling cam (19). There should be a spring loaded plunger called an eyelet (16) that protrudes from the tower on the canceling cam. You should be able to freely depress the eyelet against the small spring (17) inside the tower. Insulator (15) holds them in place. It can now be removed to access the eyelet and spring if these parts are to be inspected or replaced.

Note: From this point onward please refer to the steering wheel drawing on page 2. Assemble plastic covers and escutcheon (1967) or covers and closeout panel (1968). Place the canceling cam (19), the large spring (14), and the steering wheel hub assembly (13) on the steering shaft. The horn tower on the canceling cam (with the eyelet, spring, and retainer) fits through the hole in the hub. Align the mark on the hub to the mark on the end of the steering shaft. Assemble washer (12) and steering hub nut (11). Torque nut to 35 ft-lbs.

Place the spacer (8) on the steering wheel hub assembly. Set the telescope locking lever (7) on top of the spacer (with the steering wheel straight ahead, the finger tab part of the lever should be in the 12 o'clock quadrant). Thread the special "star" screw (4) into the end of the steering shaft. Now, use a phillips screwdriver to tighten the "star" screw until you can no longer telescope the steering shaft. Place the finger part of the locking lever at about the 1 o'clock position. Secure the locking lever to the "star" screw in that position with the two small screws (3). Torque them to 30 inch-lbs. You can now test the effort required to lock and unlock the telescope feature. Readjust the locking lever to suit your preference.

Place the shim(s) (5) and the upper horn contact (6) on the spacer. Attach the horn contact to the hub with three screws (2). Torque to 19 inch-lbs. Make sure that the eyelet plunger (16) sticking up through the hub touches the horn contact. Snap on the horn cap (1).

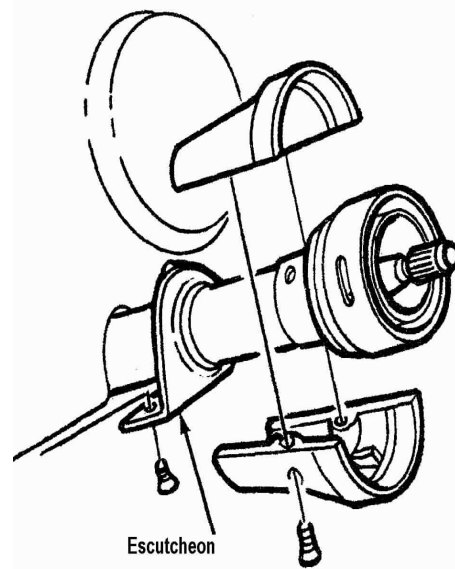
1967 CORVETTE STEERING COLUMN COVERS

Go down under the dash and disconnect the curved turn signal switch connector from the vehicle body harness. The 1967 steering column has a part called an escutcheon #7 installed on the steering column jacket #10. It serves to close the gap between the instrument cluster and the steering column. Detach the two plastic covers from the column head by removing two screws. Remove the two screws that attach the escutcheon to the dash.

You will now have access to remove the metal turn signal switch wiring protector #1 by removing the two screws #2 and unsnapping it from the jacket. The turn signal switch wires pass through a narrow gap between the escutcheon and the column jacket.

However, the curved plastic electrical connector is too large to pass through the gap. The shop manual says to just go under the dash and cut the wires. So if you are sure that your switch is toast (never to be used again) you can consider this approach. Otherwise, you will need to remove the individual wires and contacts from the connector and pull them through the escutcheon a few at a time.

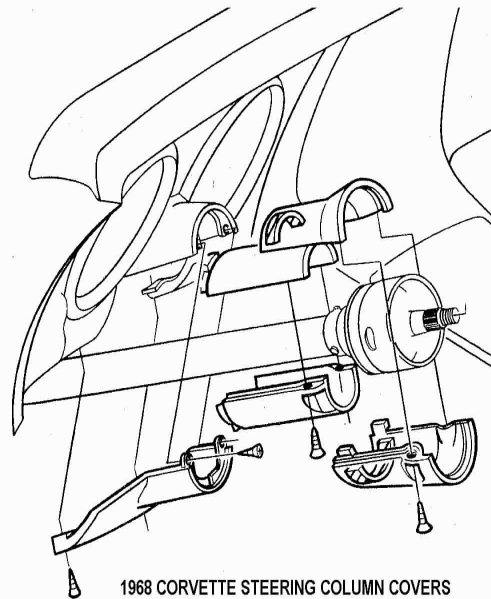
Go down under the dash and disconnect the curved turn signal switch connector from the body harness. In order to gain access to metal trough #1 that protects the wiring you will need to remove the covers and closeout panel that surrounds the steering column. Remove the fasteners and the four plastic covers that enclose the upper end of the steering column. Remove the four fasteners and the closeout panel that is underneath the column.

Remove the two screws #2 on the sides of the steering column jacket that hold the metal turn signal wiring protector #1 in place. Unsnap the protector from the mast jacket. The wires are now free to pass up and through the bearing housing #5 and the signal switch cover #6.

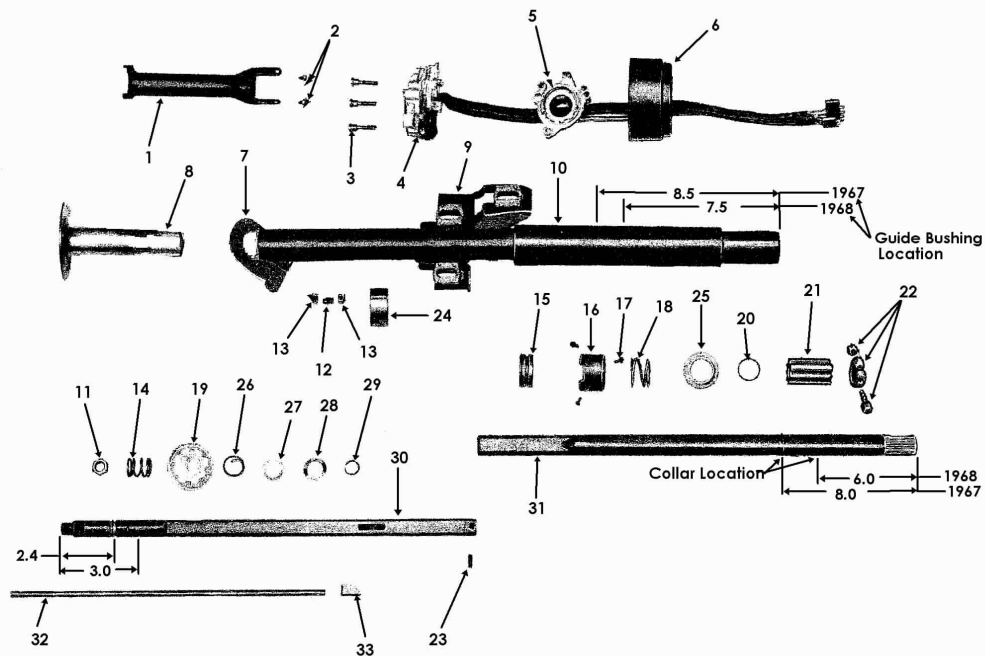
1967 (Late) Corvette Telescoping Steering Column Blowup

1968 Telescoping Steering Column Similar

There are errors in the 1967 and 1968 Chevrolet Chassis Repair Manuals where they show steering column blowup drawings. I have updated the blowup drawing in the following areas:

- 1). There is a round wire retaining ring #29 on the upper telescoping shaft #30. It is installed in a groove that is located 3.0 inches from the steering wheel end of the shaft. That ring is GM #5694191 and is available through GM dealers, numerous Corvette suppliers, or at salvage yards.
- 2). There is also a spiral pin #23 that is pressed into the other end of that shaft.
- 3). The lower bearing package shown in the 1967 manual is completely wrong. Parts shown in the 1968 manual are misidentified. Lower bearing parts (#15, 16, 17, 18, 25, 20, 21, 22) shown in my blowup now match the engineering drawings.
- 4). There is a small collar that is permanently assembled on the lower steering shaft that seats the lower bearing. It is not serviceable but its location differs from 1967 to 1968.
- 5). The bumper and keys are misidentified. There are two keys #13 and one bumper #12.

Assemble the upper bearing housing #5 and turn signal switch #4 into the cover #6. On the 1967 column pass the turn signal switch wires through the escutcheon #7. Assemble the parts over steering shaft #20. Secure parts to the upper tube and flange #8 with three screws #3 tighten to 30 inch-lbs.

Slide wave washer #28, thrust washer #27, and spiral retaining ring #26 onto steering shaft. Press parts together and seat retaining ring into groove in steering shaft. Make sure that the retaining ring is fully seated.

Pull signal switch wires flat to mast jacket #10 and assemble metal wiring protector (1) to jacket and secure with screws #2. Torque screws to 22 inch-lbs. 1967 column reattach the curved turn signal switch connector to the wires. Reconnect the turn signal switch connector to vehicle body harness.
