**STEERING WHEEL & STEERING SYSTEM CENTERING PROCEDURE
(CORVETTE 1963-82, CAMARO/FIREBIRD 1967-69, AND NOVA, SKYLARK,
VENTURA, APOLLO 1968-74, & OTHER GM REAR STEER VEHICLES)**

Procedures Addressed in this Paper	Page
SETTING THE GEAR EXACTLY ON CENTER	2
CHECKING CONDITION OF FRONT END COMPONENTS	3
STRG COLUMN SHAFT TO STRG WHEEL HUB ALIGNMENT	4
DRIVE EVALUATION	5
ADJUSTING TIE RODS	5 & 6

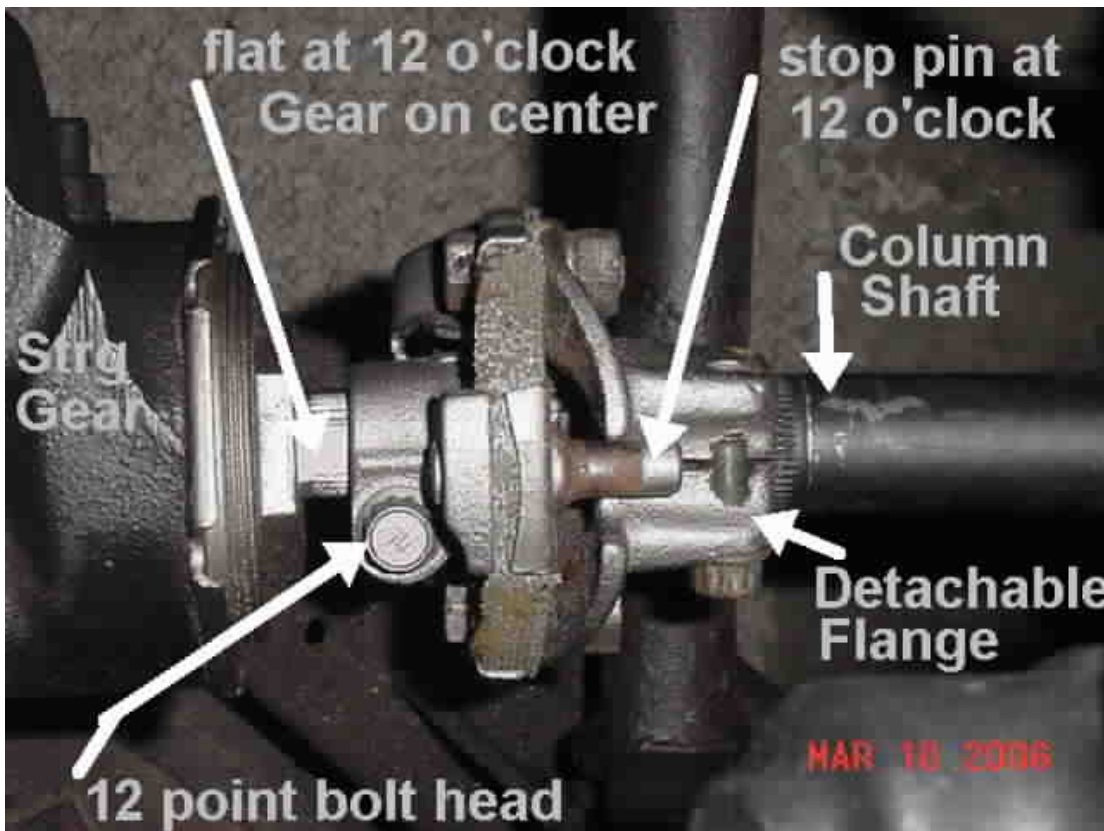
Picture of a C3 Corvette looking over the front fender, straight down at the steering gear, flexible coupling, and steering column flange. Components are shown with the steering gear exactly on center. Many GM steering columns have a press fit, stamped, lower flange instead of the cast detachable flange as shown.

Now, take a piece of chalk or a crayon and mark the flexible coupling right at its top most position (12 o'clock.) With the mark you can just peek under the hood and know when your gear is right on center.
