HORN OPERATION DIAGNOSIS – MOST GM VEHICLES 1967 AND UP

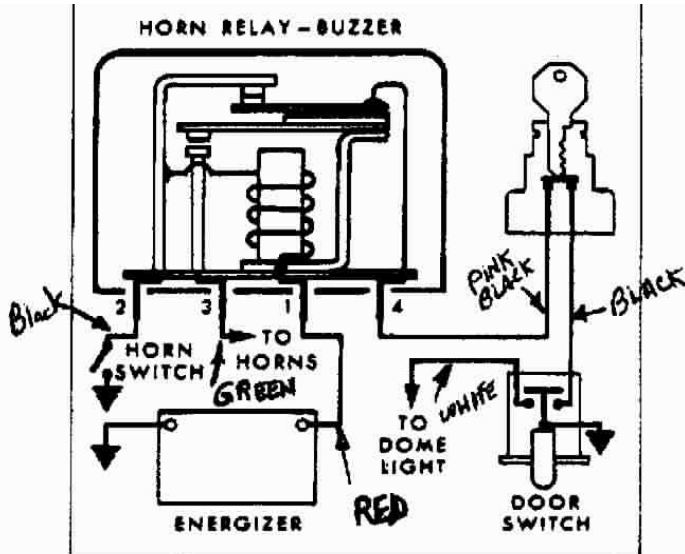
Horn Relay/Key Buzzer Schematic

All General Motors vehicles (from the 60s through the 80s) have a horn or horns that operate on the same basic principle. When you press on the steering wheel horn cap, horn button, or pad you complete a circuit to ground through the steering column and closing this circuit actuates a relay. The horns are wired directly to ground and are connected to a 12 volt source when the relay is actuated.

Remove the relay from its mounting and identify the #2 and #3 terminals. Connect a jumper from the terminal marked #2 to ground. Slide a probe into the wiring harness connector to make contact if the terminals are the slip-on type. If the horns operate, check the #2 terminal wire and horn switch for defects. If the horns do not operate, leave the #2 terminal connected to ground, and connect a voltmeter from the #3 terminal to ground. If a reading is obtained, check the horn wiring and horns for defects. If no reading is obtained, replace the horn relay/buzzer.

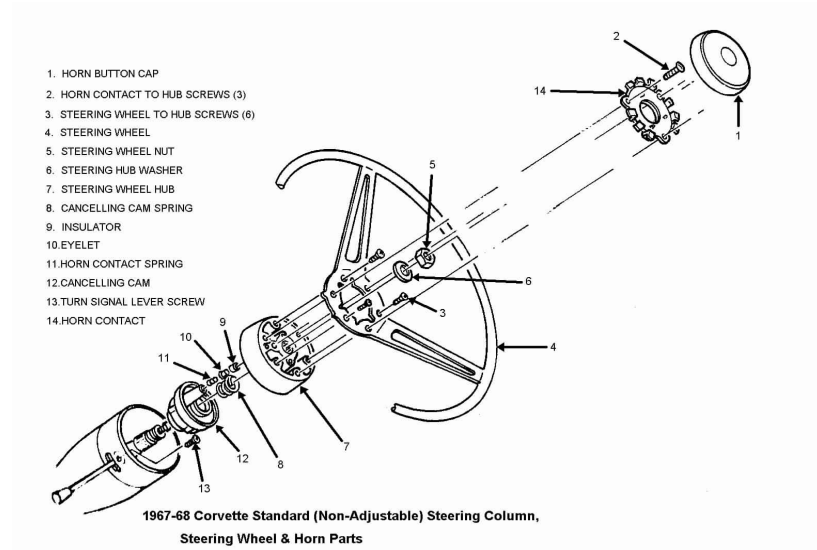
Canceling Cam & Upper Horn Contact

Note that the canceling cam is now inside the column head, behind the locking plate.

On all GM steering columns (except tilt & telescoping) the plunger extending through the steering wheel hub is part of the turn signal canceling cam assembly.

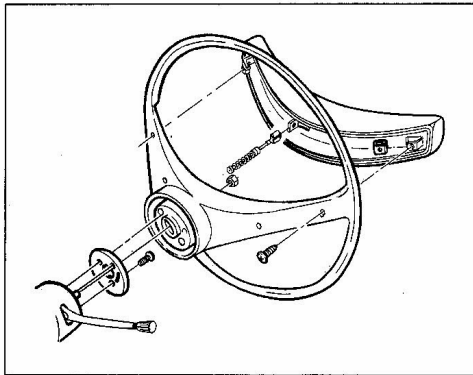
Fig. 9—Steering Wheel and Horn Attachments

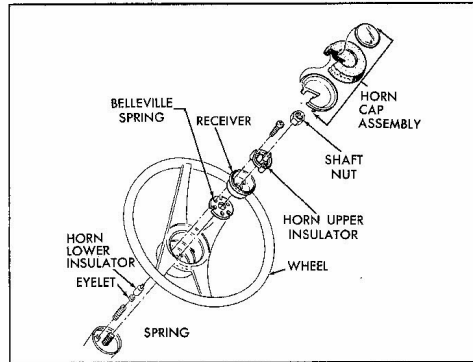
Fig. 11—Cushioned Rim Steering Wheel and Attaching Parts

Various 1969 and Later Chevrolet Steering Wheels, Pads, & Horn Caps

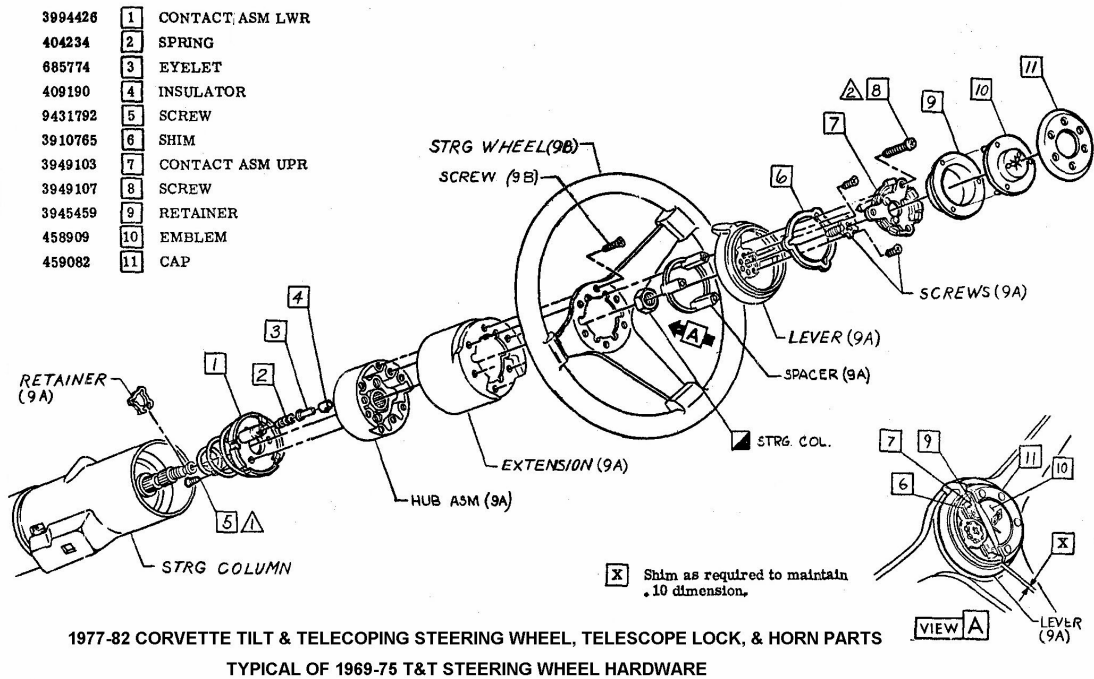
The T&T steering column is a special case where the plunger extending through the steering column hub is part of the lower contact asm #1. The lower contact asm is attached to the hub by three screws #5 and has a big coil spring that contacts the canceling cam inside the steering column head.

The plunger should rest against the underside of the upper horn contact #7. The plunger consists of a spring #2, the plunger itself (also called an eyelet) #3, and a plastic bushing (called an insulator) #4. The spring fits into the tube first, then the eyelet (upset end first) then the insulator. The insulator is either a press fit or it needs to be inserted and then rotated so that it cams into the end of the tube and retains the spring and eyelet.

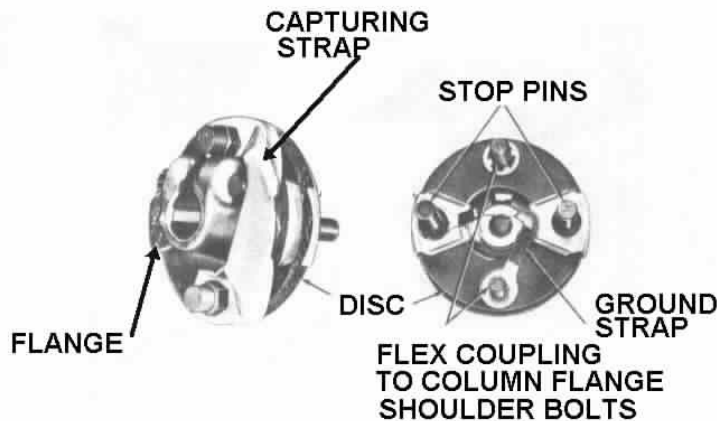
Flexible Coupling Continuity

Your OEM flexible coupling assembly has a ground wire or strap routed inside the rubber disc to provide an electrical grounding path from one side of the flex coupling to the other. On coupling assemblies manufactured after 1972 there is a molded metal screen in the face of the rubber coupling disc that provides the electrical grounding path from the steering column to the steering gear. Some aftermarket replacement units and most flex coupling rebuild "kits" do not provide a ground path. This could be the reason why your horn suddenly stops working (particularly if you just serviced the flexible coupling assembly.)
