# 1969 THROUGH 1982 CORVETTE TILT & TELESCOPING STEERING COLUMN DISASSEMBLY & REPAIR INSTRUCTIONS PAPER #3

Disassembly and Repair Instructions Addressed in this Paper

This is the third of a series of three papers that address various replacement and adjustment procedures that can be performed on the Corvette C3 tilt and telescoping (T&T) steering column.

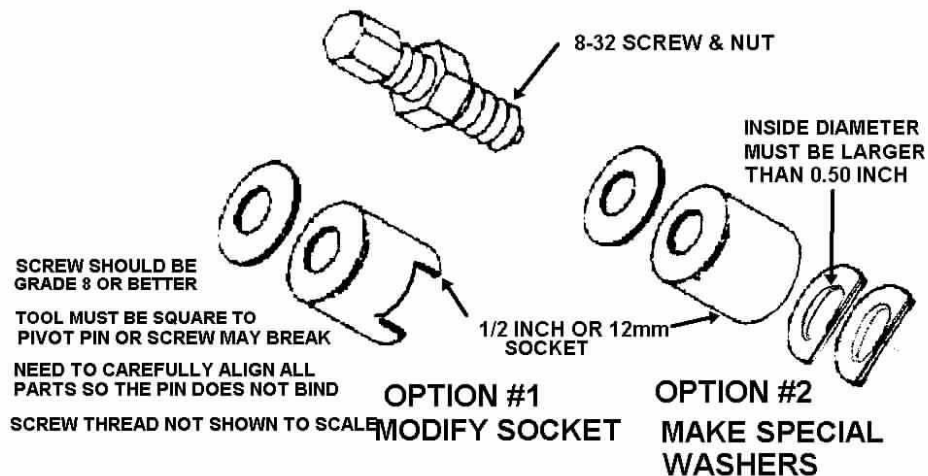
## TILT OR T&T STEERING COLUMN PIVOT PIN PULLER TOOLS

Remove the two pivot pins #35. Each of the pins has a tapped hole so that you can use the GM tool or jury rig a puller using an 8-32 screw, nut, washer, and a ½ inch or a 12mm socket. Bridge each pin with the socket and use the screw and nut to pull them out. You will note that the bowl of the transmission control lock tube housing #58 comes right up to the edge of each pivot pin. You cannot react against the fragile bowl. But you also must keep your removal tool square to the pivot pins. Two home made tools that provide clearance to the bowl and keep things square are shown on the next page.

One other method to extract the pivot pins would be to thread a 8-32 screw into the end of each pin. Grip the screw with a slam puller tool. A few quick raps should draw the pin right out.

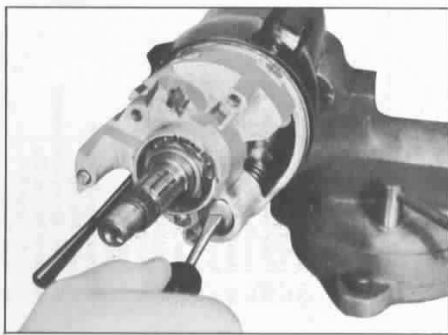
Removing Tilt Lever Spring Retainer

Remove the tilt lever spring retainer #16 using a tool that just fits into the slot opening. Note, the picture on page #6 shows a screwdriver blade being inserted into the retainer slot for removal/installation. Early retainers have a slot, later retainers have a square hole. A medium size Phillips bit will fit the square shape quite well.

**Caution:** The spring is compressed with a lot of force. Press squarely on the retainer and press in approximately 3/16 inch, turn 1/8 turn counterclockwise until the ears align with the grooves in the housing and remove the retainer, spring #17, and guide #18.

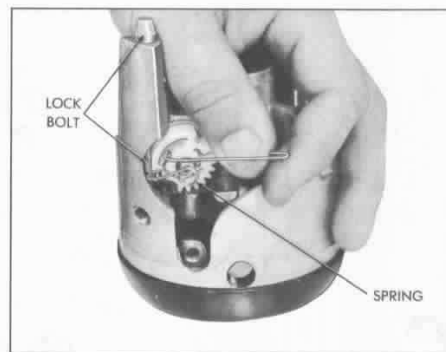
Replacing Lock Bolt Spring

Install the lock bolt spring and spring retaining screw. Tighten screw to 35 inch lbs. Install the ignition switch actuator rod through the shroud from the top and insert it in the slot in the support.

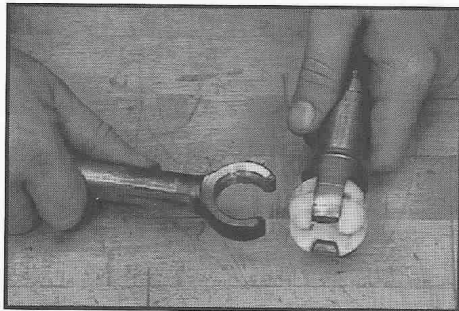
**Separating Upper and Lower Shaft Sections**

Separate the upper from the lower shaft by bending the upper shaft at a 90 degree angle to the lower shaft. You will now be able to pull them apart. The plastic sphere will remain in the yoke of the upper shaft. Rotate the sphere 90 degrees and it will slip out of the yoke. Note that there is a preload spring in between the two spheres.

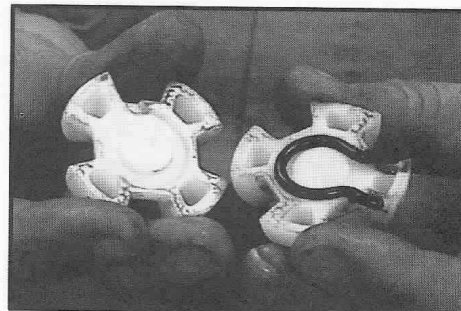
**Joint Preload Spring in Centering Sphere**

You can reassemble the shafts by first installing the spring in between the two spheres. Slide and rotate the spheres into the upper yoke. Position the lower shaft onto the upper yoke and rotate the lower shaft 90 degrees, making sure that the upper shaft and the lower shaft are oriented correctly.

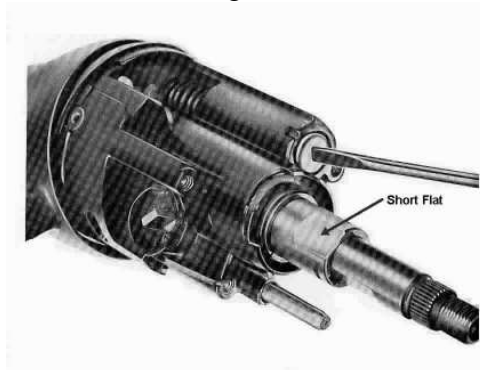
**Notice:** If for some reason you lose the original orientation of the steering shaft yoke #44 to the lower shaft #47, you will find that you will have two possible ways to reassemble this connection. If you look closely at the steering shaft yoke, you will note that the end that points at the steering wheel has two machined flats, one on each side. However, one flat is longer than the other. This is important because the carrier #4 has a flat that must mate with the long flat. The carrier also has the turn signal cancelling tabs molded into it.

If you reassemble the shaft yoke to the plastic spheres in the wrong orientation, your turn signals will not cancel properly. (You probably won't notice this problem until you have the column back in the car!)

Here is the key to the correct alignment. Look down the column from the steering wheel end, place the pinch bolt notch (located on the very lower end of the column, where the steering column flange is connected) at the 12 o'clock position. Now when the upper steering shaft is connected to the plastic tilt centering spheres, the long flat should be at the 6 o'clock position.

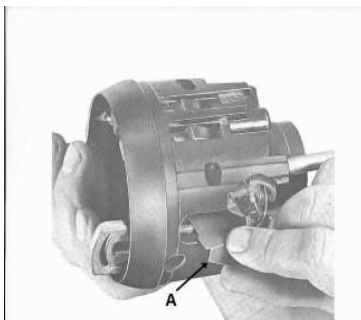
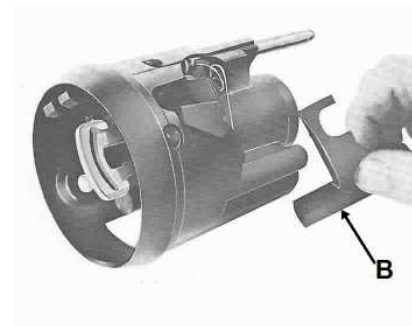
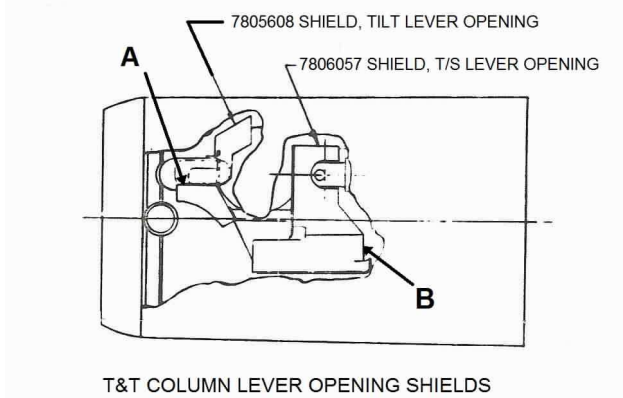
The 1969-76 T&T column has two shields. There is a tilt lever shield A and a turn signal lever shield B. The following pictures describe the installation of the two shields that are used in 69-76 column.
