# 1969 THROUGH 1982 CORVETTE TILT & TELESCOPING STEERING COLUMN DISASSEMBLY & REPAIR INSTRUCTIONS PAPER #3

Disassembly and Repair Instructions Addressed in this Paper

This is the third of a series of three papers that address various replacement and adjustment procedures that can be performed on the Corvette C3 tilt and telescoping (T&T) steering column.

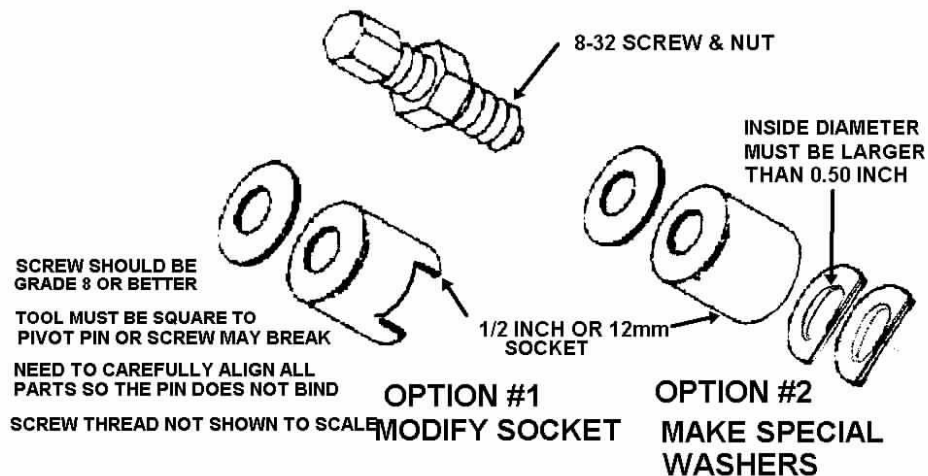
## TILT OR T&T STEERING COLUMN PIVOT PIN PULLER TOOLS

Remove the two pivot pins #35. Each of the pins has a tapped hole so that you can use the GM tool or jury rig a puller using an 8-32 screw, nut, washer, and a ½ inch or a 12mm socket. Bridge each pin with the socket and use the screw and nut to pull them out. You will note that the bowl of the transmission control lock tube housing #58 comes right up to the edge of each pivot pin. You cannot react against the fragile bowl. But you also must keep your removal tool square to the pivot pins. Two home made tools that provide clearance to the bowl and keep things square are shown on the next page.

One other method to extract the pivot pins would be to thread a 8-32 screw into the end of each pin. Grip the screw with a slam puller tool. A few quick raps should draw the pin right out.

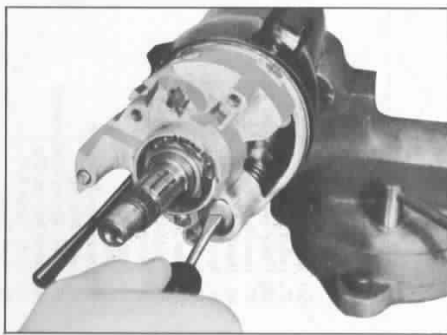
Removing Tilt Lever Spring Retainer

Remove the tilt lever spring retainer #16 using a tool that just fits into the slot opening. Note, the picture on page #6 shows a screwdriver blade being inserted into the retainer slot for removal/installation. Early retainers have a slot, later retainers have a square hole. A medium size Phillips bit will fit the square shape quite well.

**Caution:** The spring is compressed with a lot of force. Press squarely on the retainer and press in approximately 3/16 inch, turn 1/8 turn counterclockwise until the ears align with the grooves in the housing and remove the retainer, spring #17, and guide #18.

Place the housing in the full “up” position. Assemble the tilt spring #17 and spring guide #18. Apply grease between the guide and the peg on the support. Turn the tilt spring retainer #39 clockwise to secure it (shown above.)

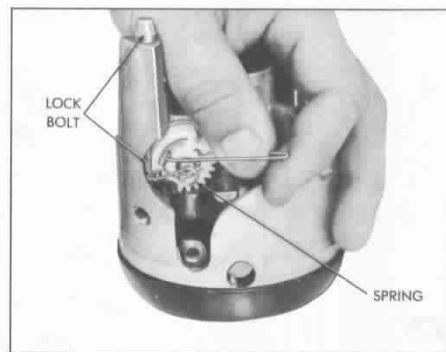
Replacing Lock Bolt Spring

Install the lock bolt spring and spring retaining screw. Tighten screw to 35 inch lbs. Install the ignition switch actuator rod through the shroud from the top and insert it in the slot in the support.

Remove the tilt lever opening shield #20 from the housing and also the turn signal lever opening shield if so equipped. Remove the lock bolt spring #23 by removing the spring retaining screw #32, and moving the spring clockwise to remove the lock bolt #22.

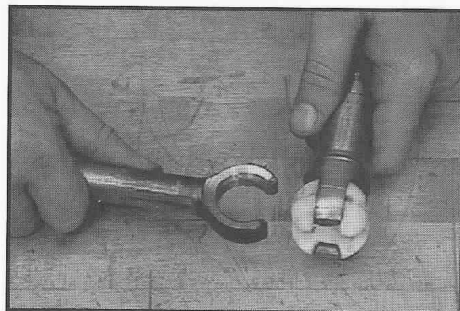
**Separating Upper and Lower  
Shaft Sections**

Separate the upper from the lower shaft by bending the upper shaft at a 90 degree angle to the lower shaft. You will now be able to pull them apart. The plastic sphere will remain in the yoke of the upper shaft. Rotate the sphere 90 degrees and it will slip out of the yoke. Note that there is a preload spring in between the two spheres.

To regain the proper amount of tightness you will need to separate the upper from the lower steering shaft. First mark the upper and lower shafts so that you can reassemble them with the correct upper to lower shaft orientation.

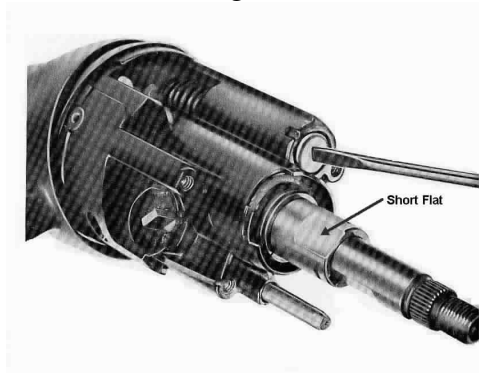
**Notice:** If for some reason you lose the original orientation of the steering shaft yoke #44 to the lower shaft #47, you will find that you will have two possible ways to reassemble this connection. If you look closely at the steering shaft yoke, you will note that the end that points at the steering wheel has two machined flats, one on each side. However, one flat is longer than the other. This is important because the carrier #4 has a flat that must mate with the long flat. The carrier also has the turn signal cancelling tabs molded into it.

If you reassemble the shaft yoke to the plastic spheres in the wrong orientation, your turn signals will not cancel properly. (You probably won't notice this problem until you have the column back in the car!)

Here is the key to the correct alignment. Look down the column from the steering wheel end. Place the pinch bolt notch (located on the very lower end of the column, where the steering column flange is connected) at the 12 o'clock position. Now when the upper steering shaft is connected to the plastic tilt centering spheres, the long flat should be at the 6 o'clock position.

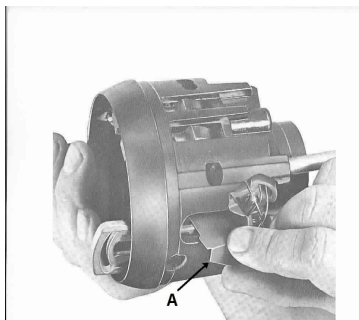
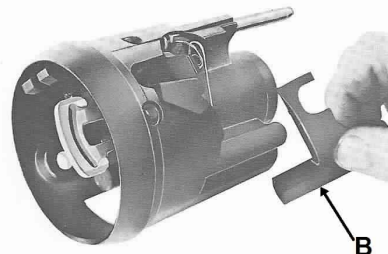
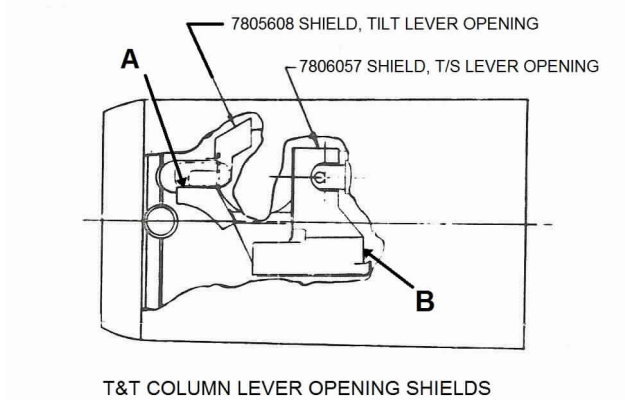
The 1969-76 T&T column has two shields. There is a tilt lever shield A and a turn signal lever shield B. The following pictures describe the installation of the two shields that are used in 69-76 column.
