## **1969 THRU 1979 CORVETTE STANDARD (NON-ADJUSTABLE) STEERING COLUMN DISASSEMBLY & REPAIR INSTRUCTIONS PAPER #3**

Disassembly and Repair Instructions Addressed in this Paper

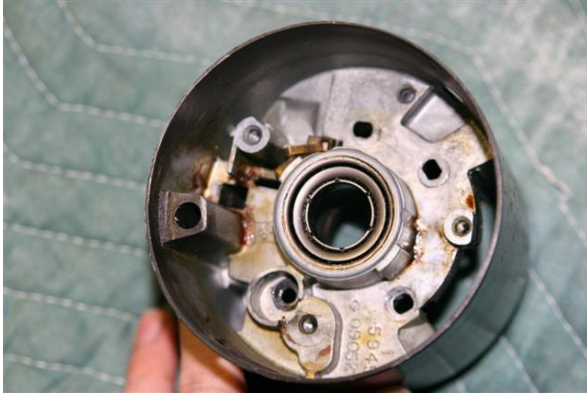
Remove the four screws #10 attaching the housing #23 to the jacket #29. On 1969-76 steering columns the upper steering shaft bearing was installed into the die cast bearing housing from the driver side and the housing lip was spun over to retain it.

Zip Products 1-800-962-9632 has the Corvette Lock Housing Assembly still available with the bearing and plastic sector. The Zip part number is SC-447. Also Dr. Rebuild 1-800-866-9362 has the same assembly. The Doc's part number is 6521512

According to the Saginaw service literature, the bearing was not serviceable. However, until recently a service bearing was available through GM dealers (part number 7800269.) If your local dealer does a search, it still might be found on dealer's shelves. The Dr. Rebuild websight lists a 1969-76 Upper Steering Column Shaft Bearing 6521108.

As a service procedure, take the housing and grind the spun lip away, then remove the bearing from the instrument panel side. The new bearing can be carefully glued or epoxied into place. However, it isn't going anywhere once the column is reassembled.
