1969 THROUGH 1982 CORVETTE TILT & TELESCOPING STEERING COLUMN DISASSEMBLY & REPAIR INSTRUCTIONS PAPER #3

Disassembly and Repair Instructions Addressed in this Paper

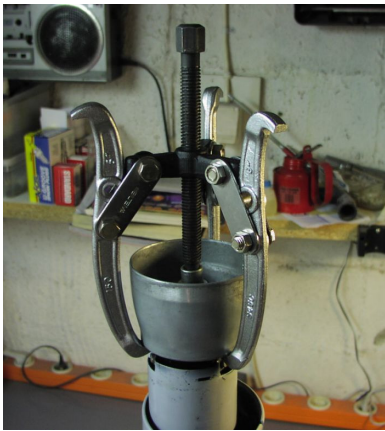
On the left is a picture supplied by a Corvette owner who rigged a rather large three jaw puller to separate them. Make sure that the socket or bushing that is being used to press on the shift tube end will clear the boss in the bowl.

The Chevrolet Chassis Service Manual and my Corvette T&T Column Disassembly Instruction Pic #3 shows a special tool (J-23072) being used to separate the bowl from the shift tube. They also show special tool (J-23073) to reattach the two parts. These tools are hard to find and very expensive.
